December 15, 2011

**Re: Pond Consultation – for ██████████ Grey Road 12, Meaford, Ontario**

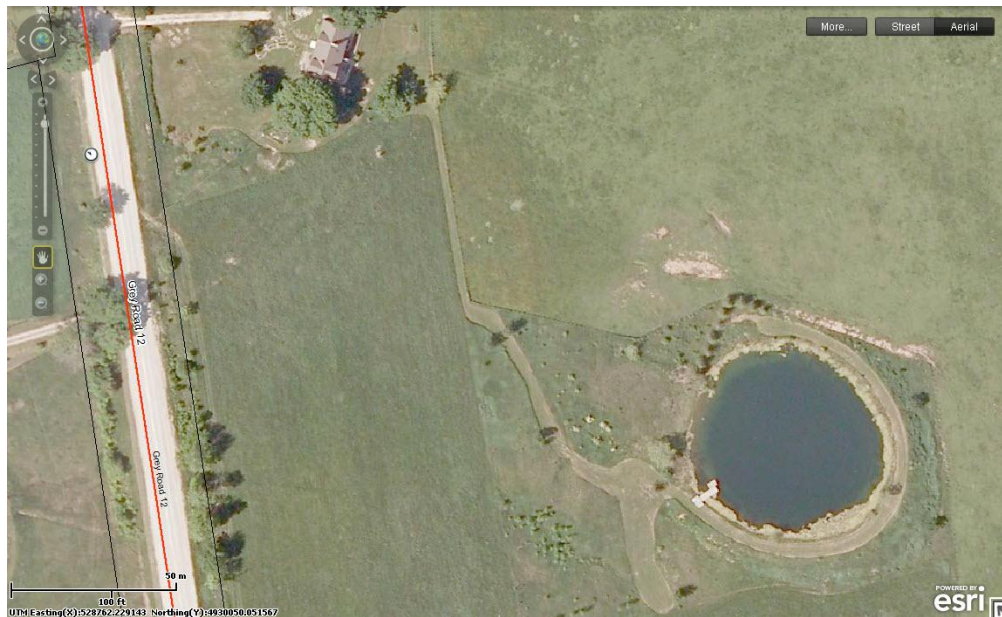
**Figure 1-Site Overview**

The pond is approximately 33,000 square feet (0.75 acres) in terms of surface area (See Figure 1). Based on its physical location (cut into the side of a hill) and your observations that the water level fluctuates very little throughout the year, the most likely water source for the pond is ground water seepage/upwelling. We also observed a 6-inch "Big O" tile drain situated uphill and northeast of the pond which was actively feeding water to the pond. It was unclear as to the exact source of the tile drain or the extent of the area which it drains. The amount of water entering the pond from the tile drain was clearly less than the amount leaving through the overflow pipe, again suggesting the infiltration of

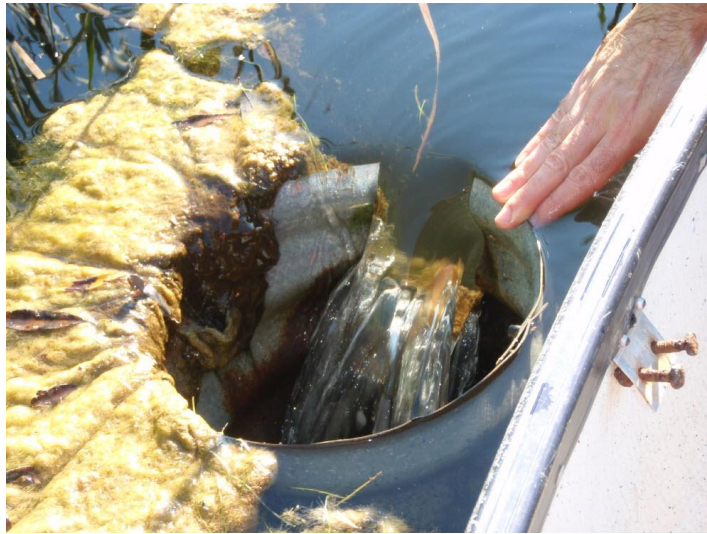
**Figure 2 – Overflow Pipe**

Water exits the pond through a vertical corrugated steel culvert at the east end of the pond (Figure 2). This pipe discharges to another pipe which ultimately discharges the flow into a nearby watercourse. There also appears to be an emergency spillway situated on the west bank of the pond in the general vicinity of the dock. Based on visual observation, this area appears to be lower in elevation than the rest of the retaining berm such that in a severe flood event - flow would be directed over the berm in a small contained area as opposed to sheet flow over the entire berm. There was very little if any evidence of any erosion problems associated with the pond or the surrounding area.

Water clarity was fairly turbid (unclear) with a measured Secchi depth of 1 metre. (A Secchi disk is a sampling device used to measure how deep a person can see into the water.) A shallow Secchi depth can be an indication of high amounts of phytoplankton (suspended algae) activity. Riparian (or shoreline) vegetation is well established around the entire perimeter of the pond and a species inventory was recorded and has been included as an attachment to this report (See Attachment 1). We also observed quite a few floating mats of filamentous algae around the periphery of the pond (see edges of the stand pipe in Figure 2). Once again this is a potential indicator of nutrient issues.

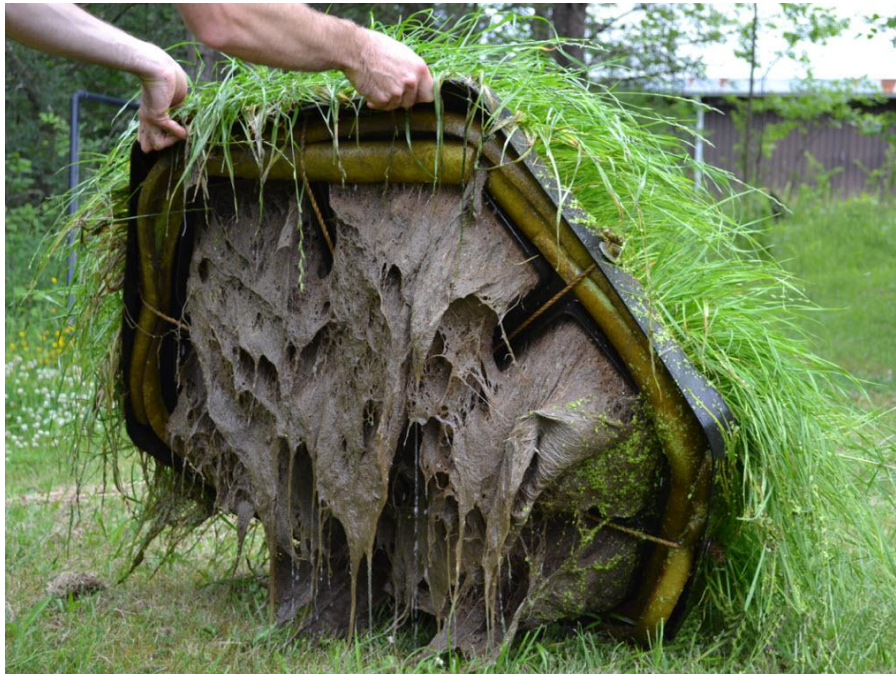
**Figure 5-A** module of PhytoLinks™ Floating Treatment Wetland System

C&M has conducted extensive research on floating islands technology and have developed our own proprietary version called PhytoLinks™ (See Figure 5). We are also currently researching the notion of harvesting plants from our islands as a means of physically removing nutrients like phosphorous and nitrogen from aquatic environments.

Ponds with nutrient issues such as algae blooms etc. require coverage of up to 5% of the surface area of the pond. The shape and location of the islands would ultimately be determined through collaboration between you and C&M.
